MILL CREEK NO. 2 DAM  
NDI I.D. NO: 735

PHASE I INSPECTION REPORT  
NATIONAL DAM INSPECTION PROGRAM

Mill Creek Number 2 Dam (NDI-735),  
Ohio River Basin, Mill Creek,  
Cambria County, Pennsylvania.  
Phase I Inspection Report.

<sup>11</sup> SEPTEMBER 1978

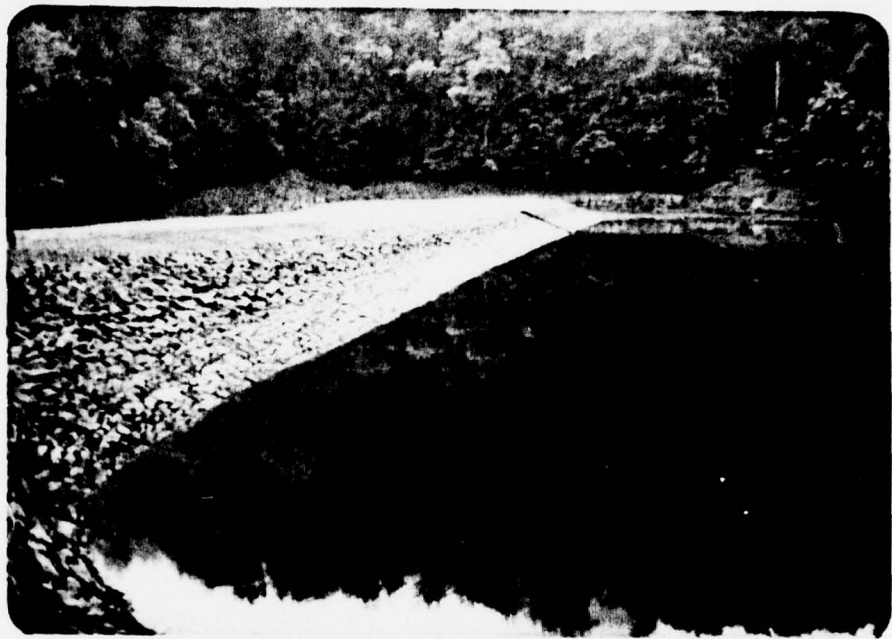
Upstream Face

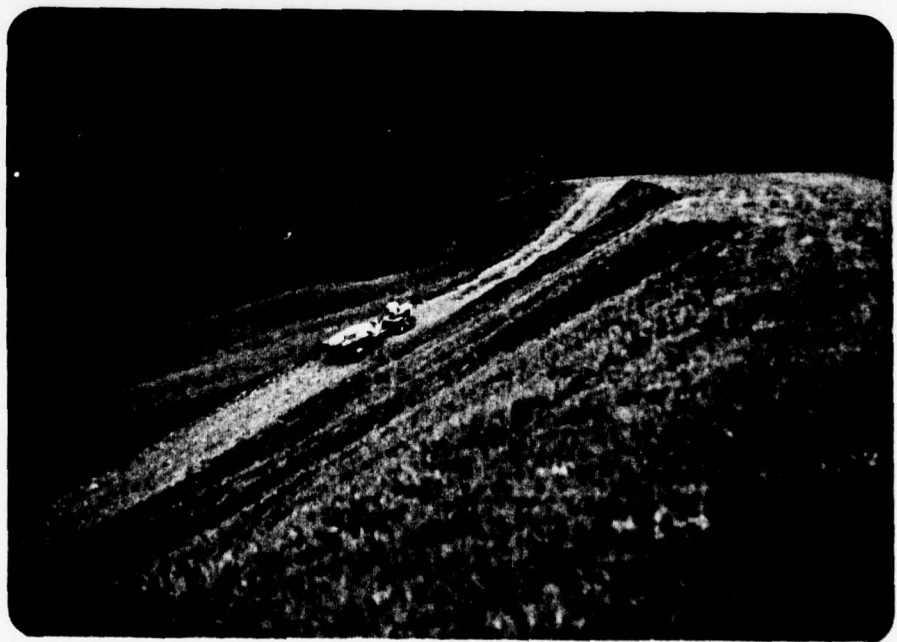
Downstream Face

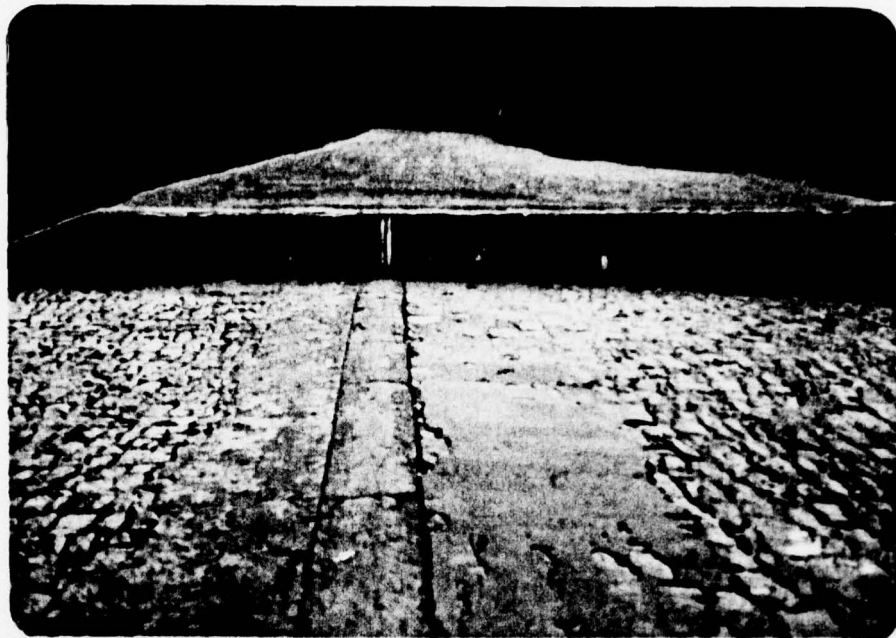
Photograph No. 1

Crest (looking east) (spillway crest  
in foreground).

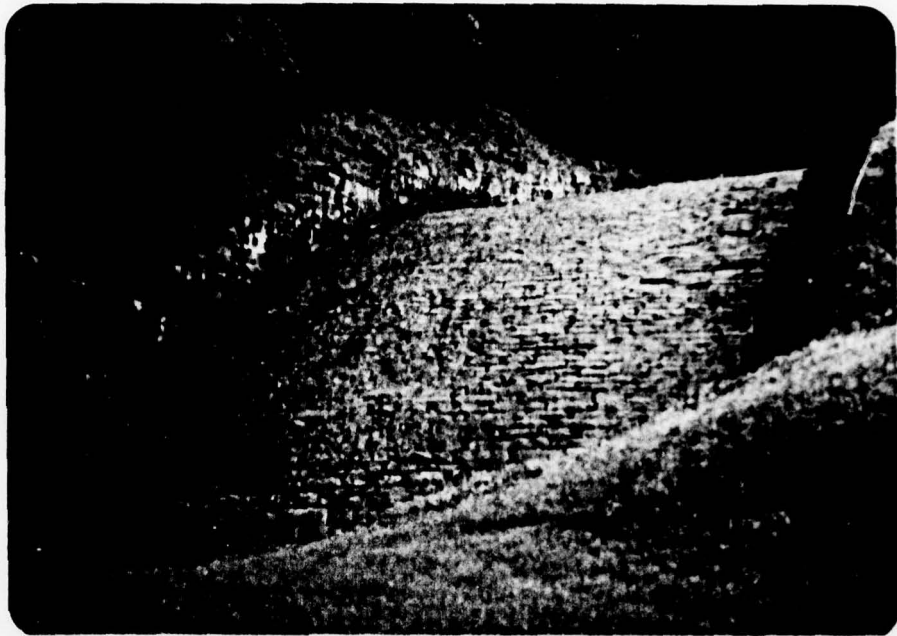
Photograph No. 3  
Spillway discharge channel.

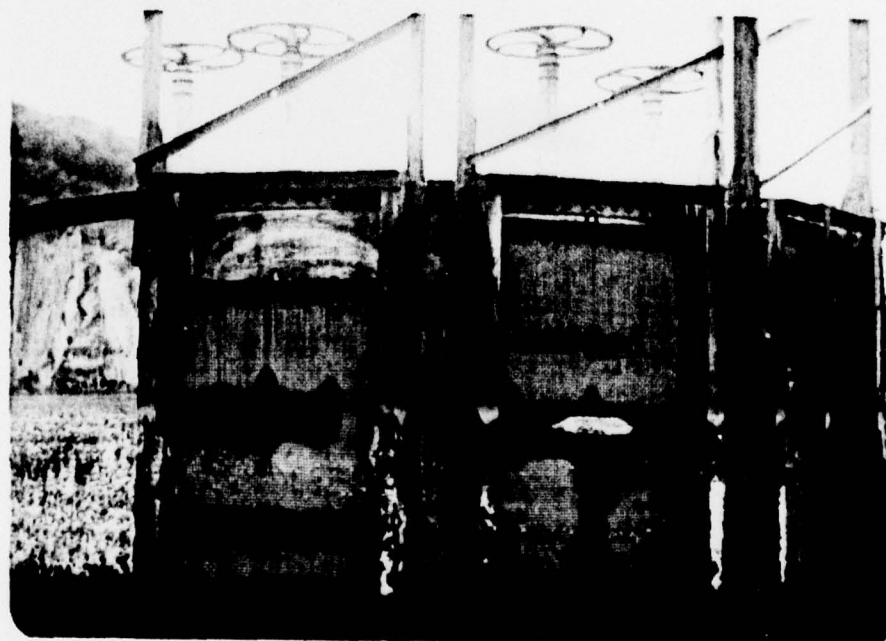
Photograph No. 6  
Gate controls at intake tower.

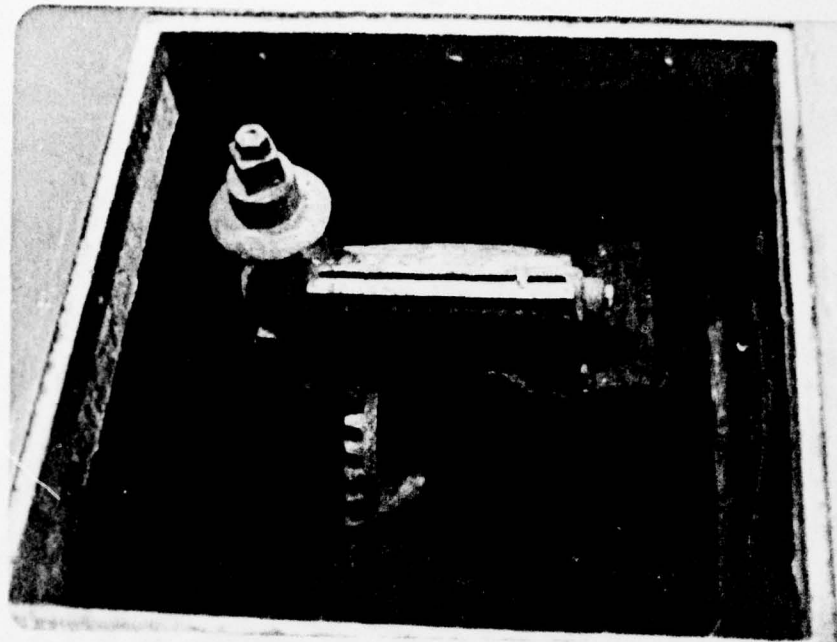
4.3 Maintenance of Operating Facilities. The maintenance condition of the operating facilities is considered to be poor. The dam tender reported that the downstream blow-off valve for the dam has not been operated in the past 25 years and only two intermediate level intake valves in the intake tower are functional. The upper and lower intake valves are closed and their operational condition is reported to be unknown. The operation of the blow-off valve was not observed.

Photograph No. 7  
Blow-off valve at valve house.

1. The owner immediately initiate studies to more accurately ascertain the spillway capacity and the nature and extent of improvements required to provide sufficient spillway capacity.
2. The owner immediately evaluate the operational condition of the outlet works system and perform any necessary maintenance and/or repairs to make it functional.

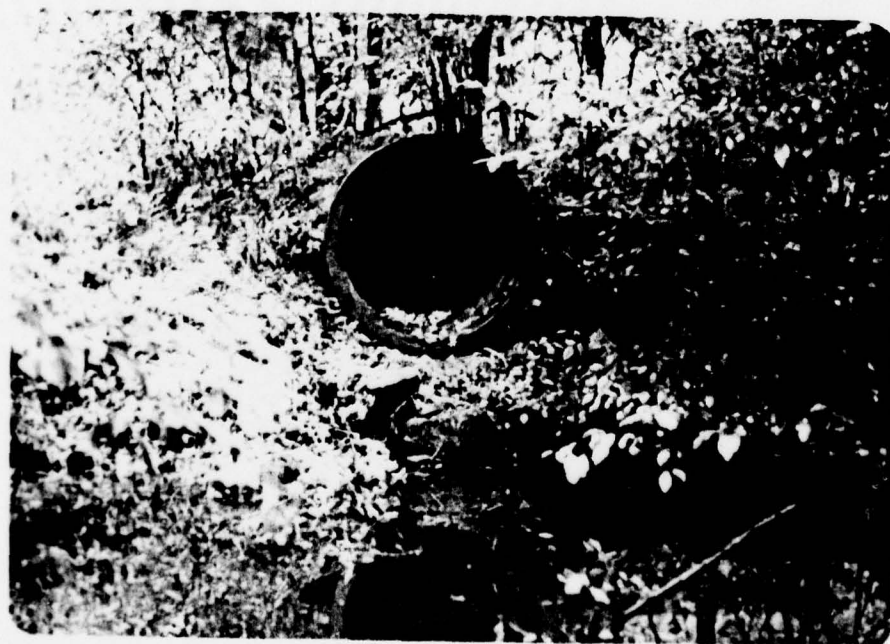
Photograph No. 8  
Blow-off pipe.

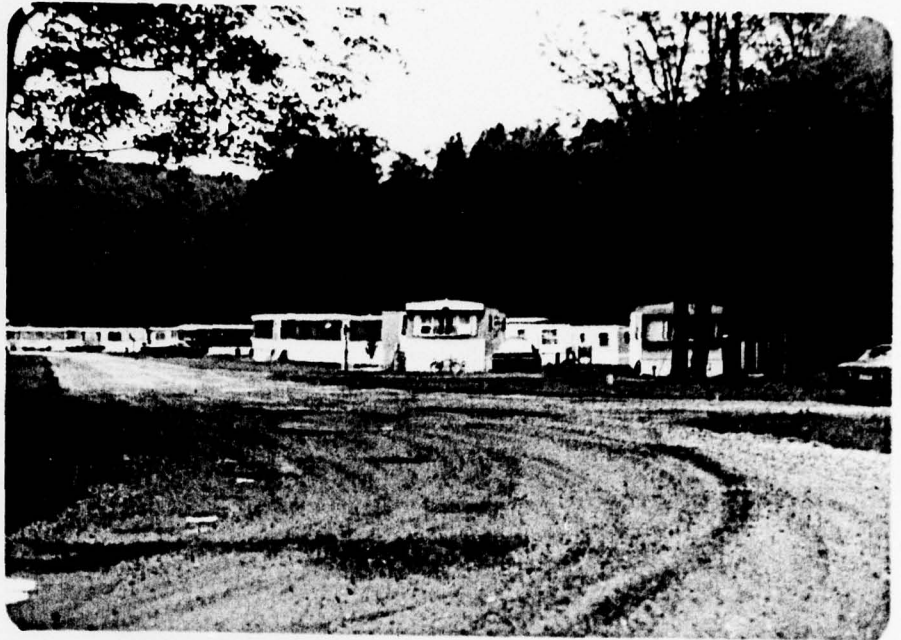
Photograph No. 9  
Mobile home park (1-1/2 miles downstream).

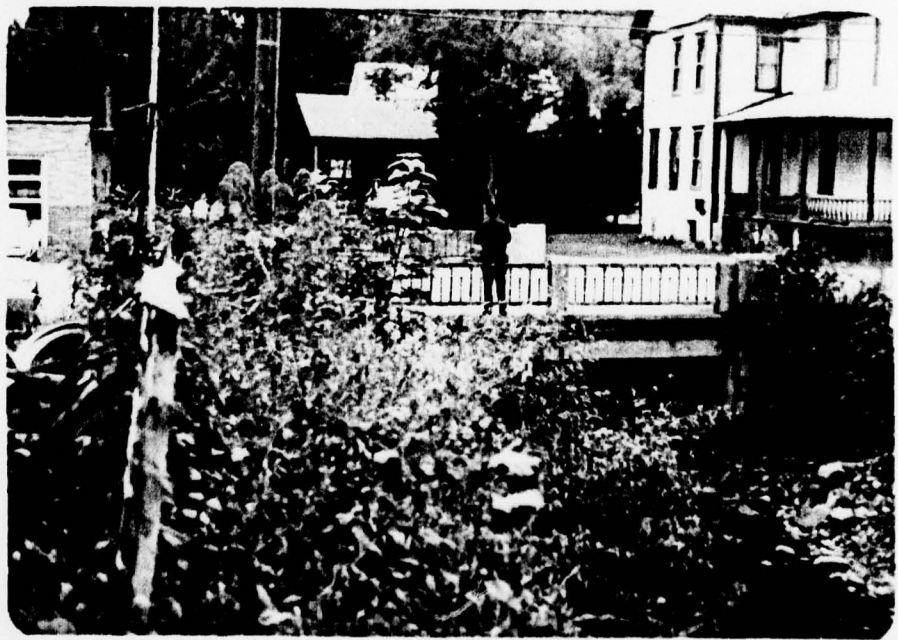
Photograph No. 10  
Bridge over Mill Creek (two miles downstream).
